PDI (New Car Inspection) Report

ID: 2633

Car: NEXON

Car Variant: CREATIVE+ S DK PMT ICNG

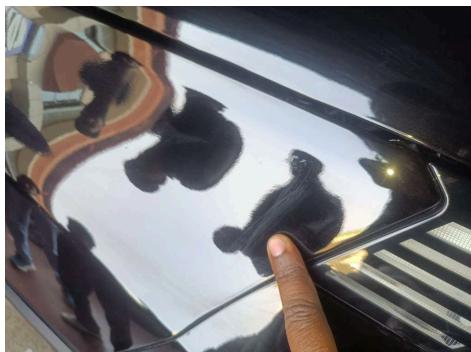
Driver - Front Fender Image

Driver - Front Fender: MINOR SCRATCHES

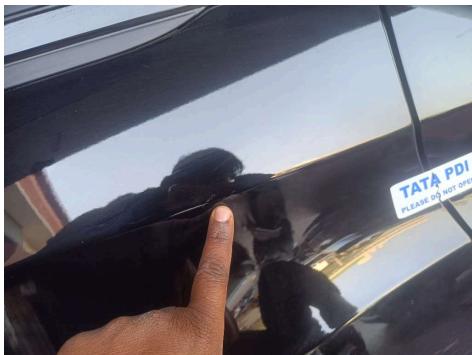
Driver - Back Quarter Panel Image

Driver - Back Quarter Panel: MINOR SCRATCHES

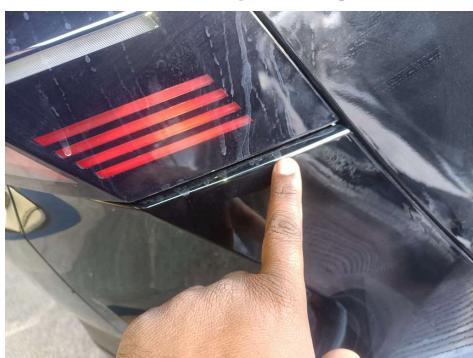
Rear Bumper Image

Rear Bumper: PANEL GAPS

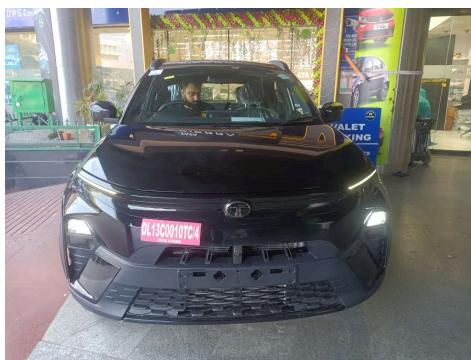
Fog Light's Image

Fog Light's: NOT AVAILABLE

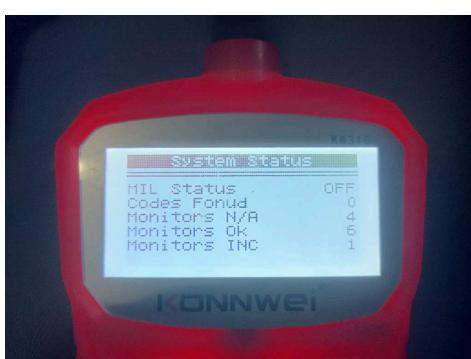
OBD Scan Photo

Any Fault Code Present: No

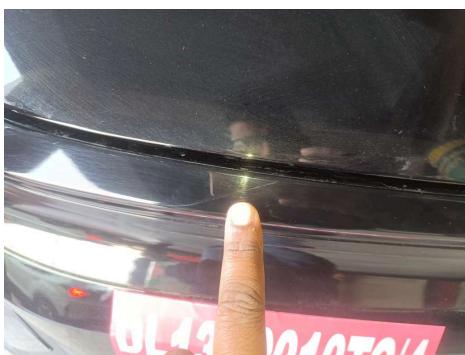
Issue Photo 1

Any Issues Found in Car: SOME PANEL HAVE SCRECHES REAR BUMPER GAP, FRONT BUMPER HARELINE SCHRECH, RHS RUNNING BOARD SCRECHES, RHS A PILLER HERELINE SCRECHE
